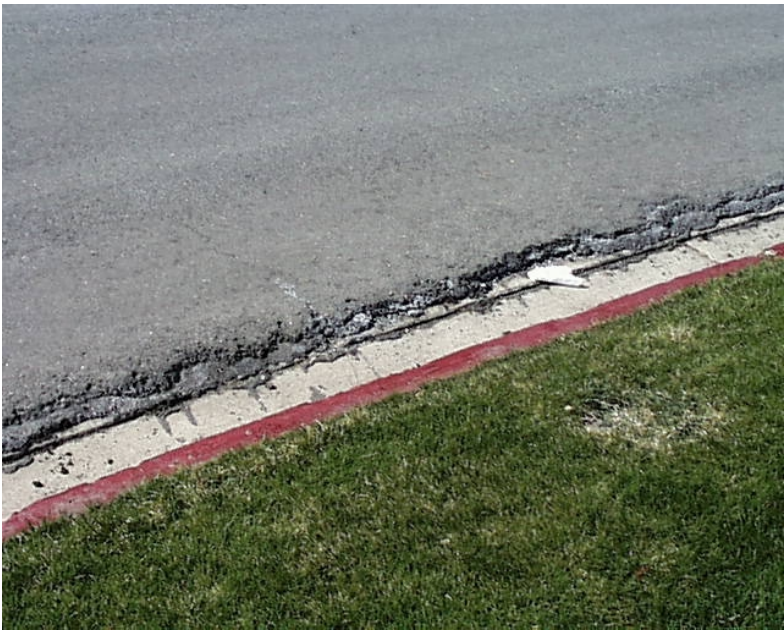
<b>ID</b>	<b>74</b>
-----------	-----------

<b>Category:</b>	<b>Parking</b>
<b>Location:</b>	<b>Typical of site access roads and parking areas</b>
<i>Satisfactory:</i>	<input type="checkbox"/>
<i>Damaged:</i>	<input type="checkbox"/>
<i>Condition Code:</i>	
<i>Condition Description:</i>	
<i>Comments:</i>	Typical layering of asphalt over concrete surfaces for roads and parking areas.

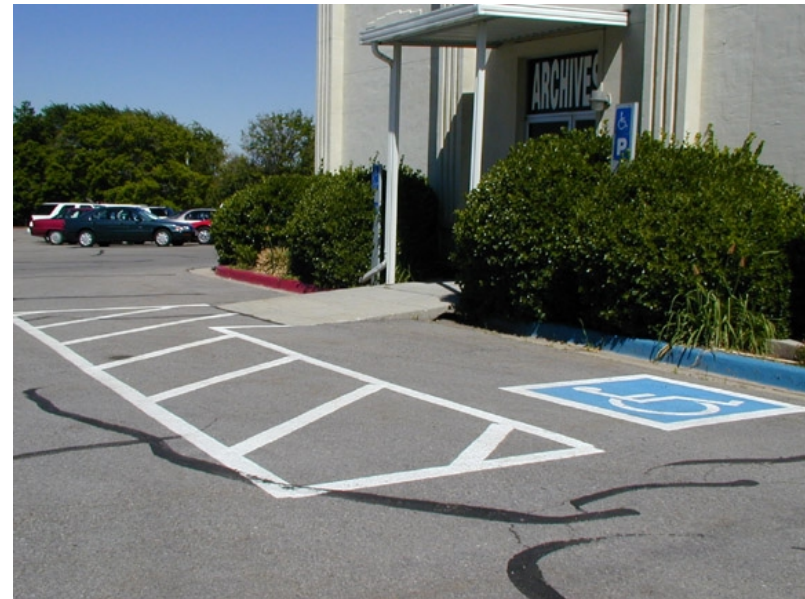
ID 75

*Comments:* Handicap parking with ramp adjacent to door.

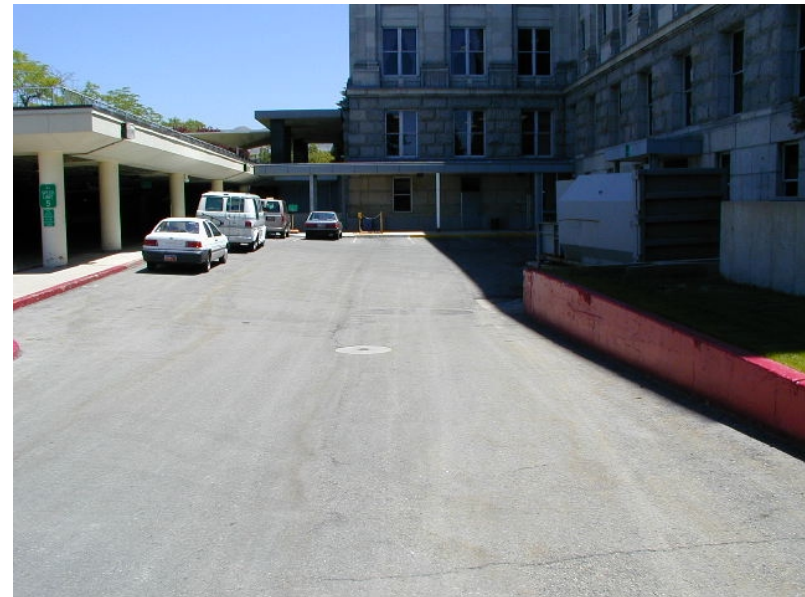
**ID**    **76**

Asphalt, good condition. Note limited parking and unaesthetic location adjacent to Capitol building.

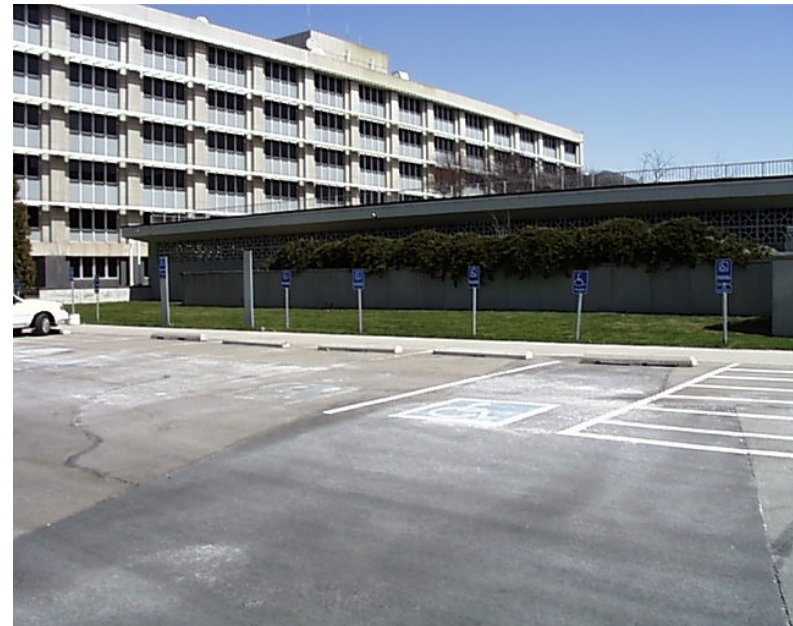
ID 77

Non-standard handicap stalls, only regular stalls signed as handicap.

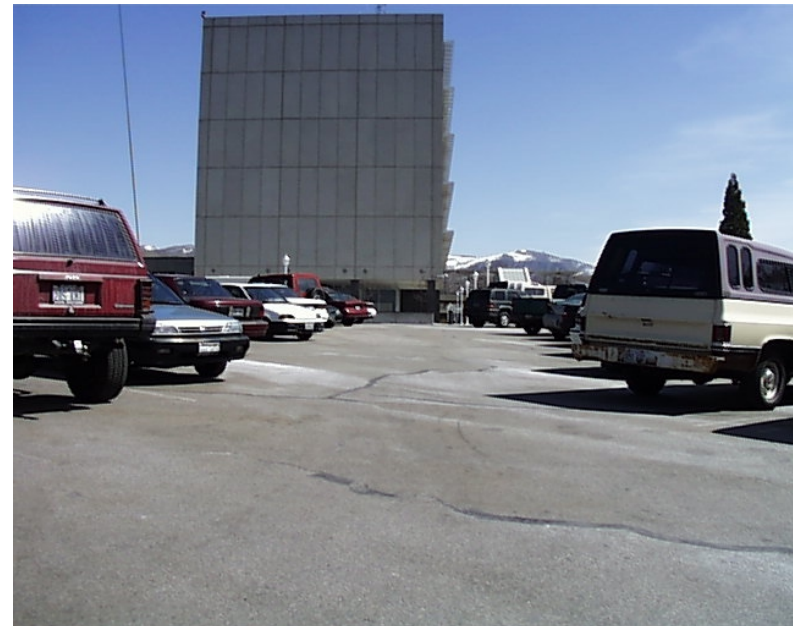
ID 78

Asphalt, good condition. Note lane widths are narrow in this parking area, difficult for larger vehicles.

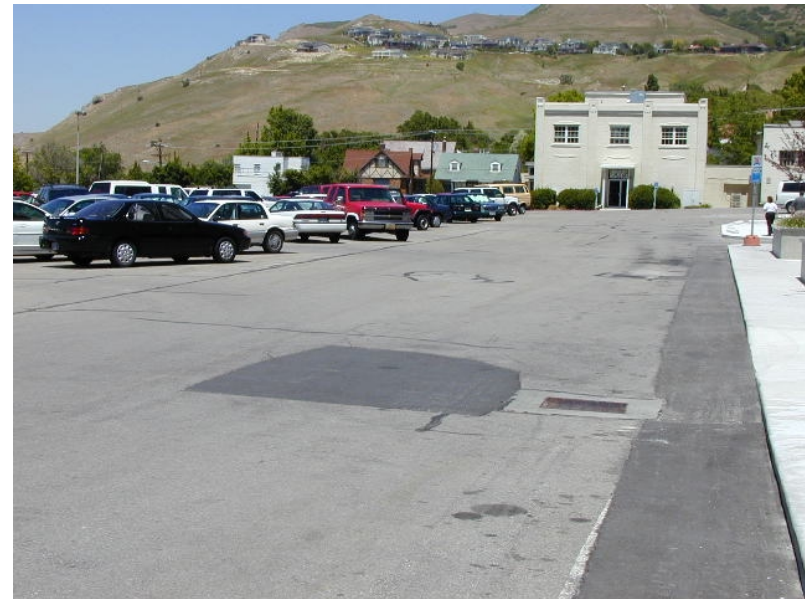
ID 79

Typical bus access to State Office Building on right edge of pavement. Asphalt patches typical of all parking areas.

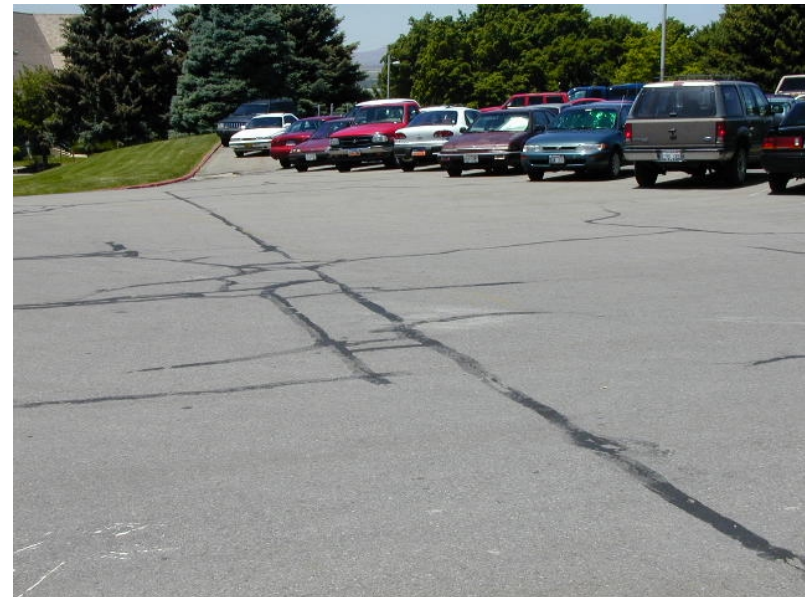
**ID**    **80**

*Comments:*              Entrance from Columbus Street -- no striping as to which travel lane to drive in or which area to park in.

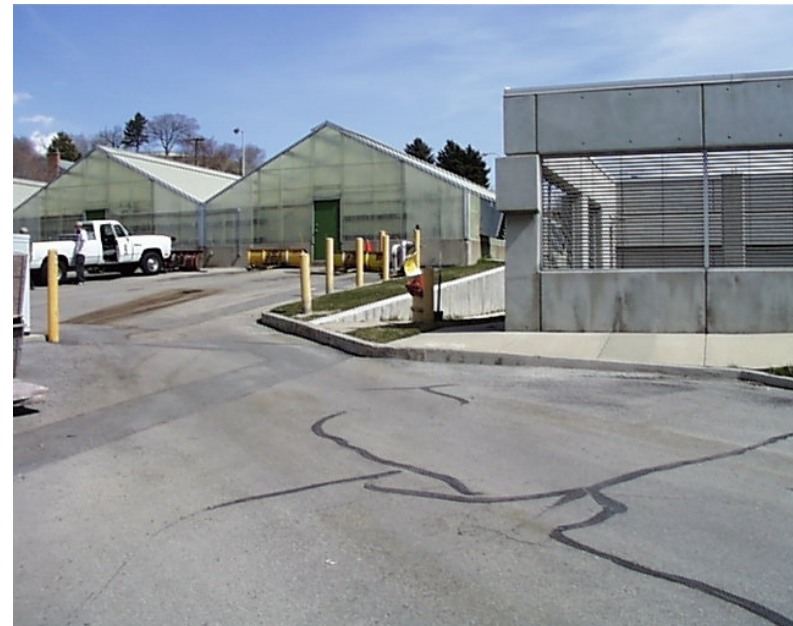
**ID**    **81**

Difficult maneuvering through poles for fire truck access to hydrant.

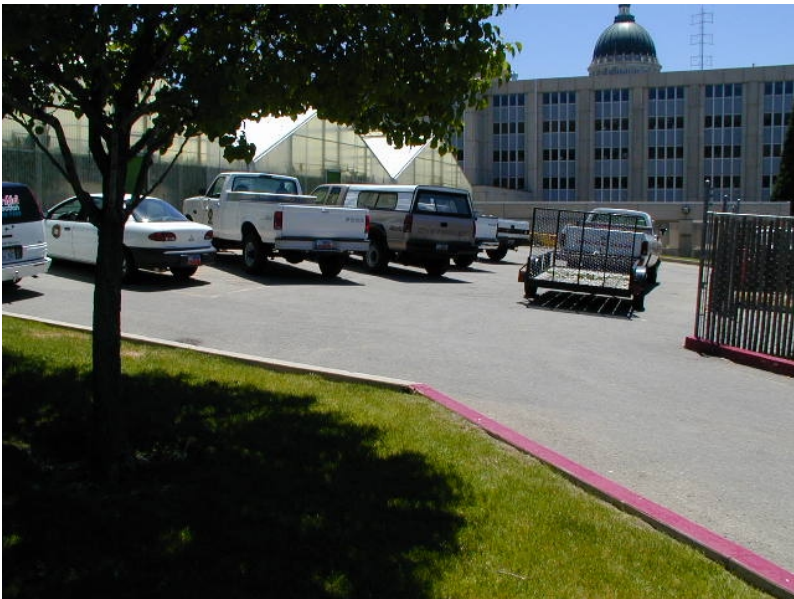
<b>ID</b>	<b>82</b>
-----------	-----------

<b>Category:</b>	<b>Parking</b>
<b>Location:</b>	<b>Greenhouse Facility, from 500 North</b>
<i>Satisfactory:</i>	<input type="checkbox"/>
<i>Damaged:</i>	<input type="checkbox"/>
<i>Condition Code:</i>	O
<i>Condition Description:</i>	Other (describe)
<i>Comments:</i>	Limited parking.

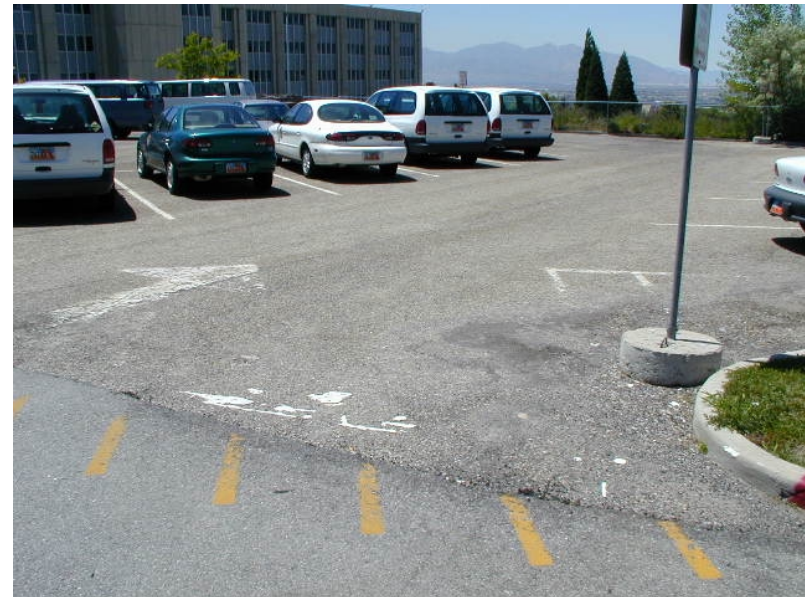
ID 83

*Comments:* Faded striping, some loose gravel

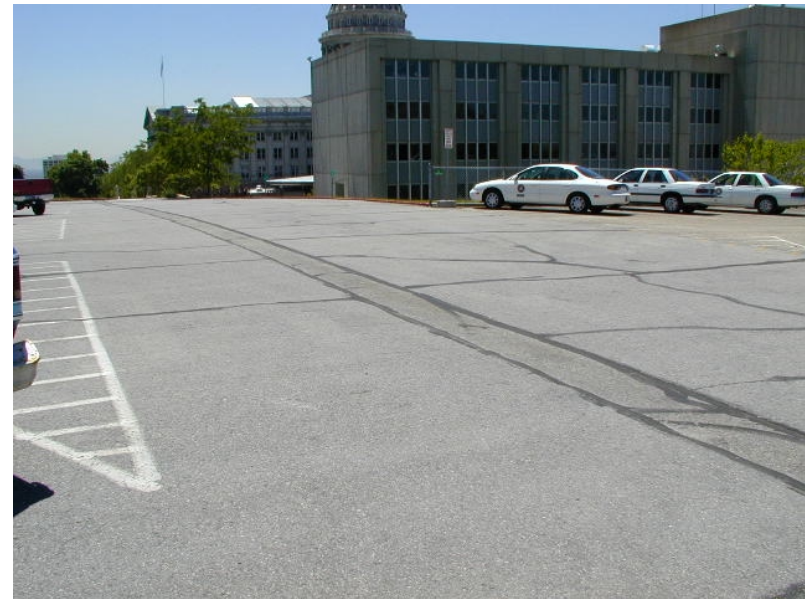
**ID**    **84**

Standard travel lane into parking area.

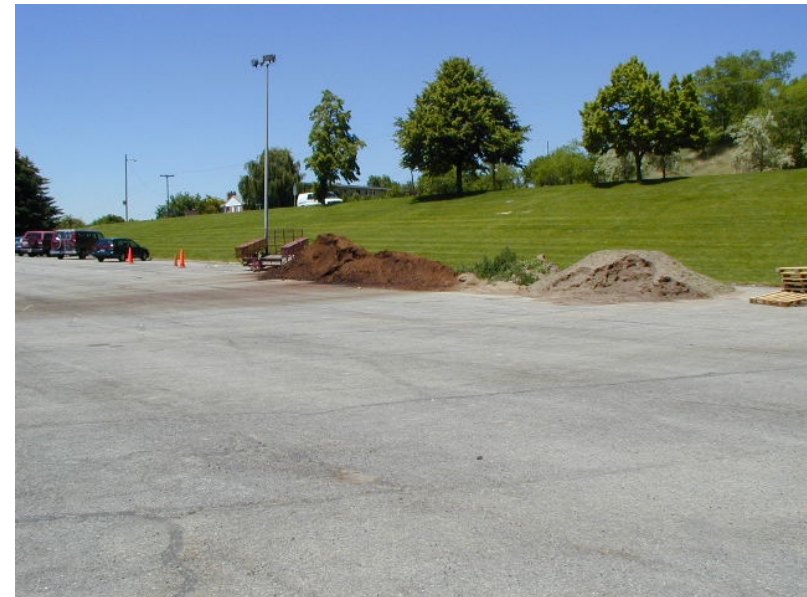
**ID**    **85**

*Comments:*                   Parking area used for soil and dumpster storage  
in spring/summer, snow storage in winter.  
Relocate these types of storage. Clean up  
soiled asphalt.

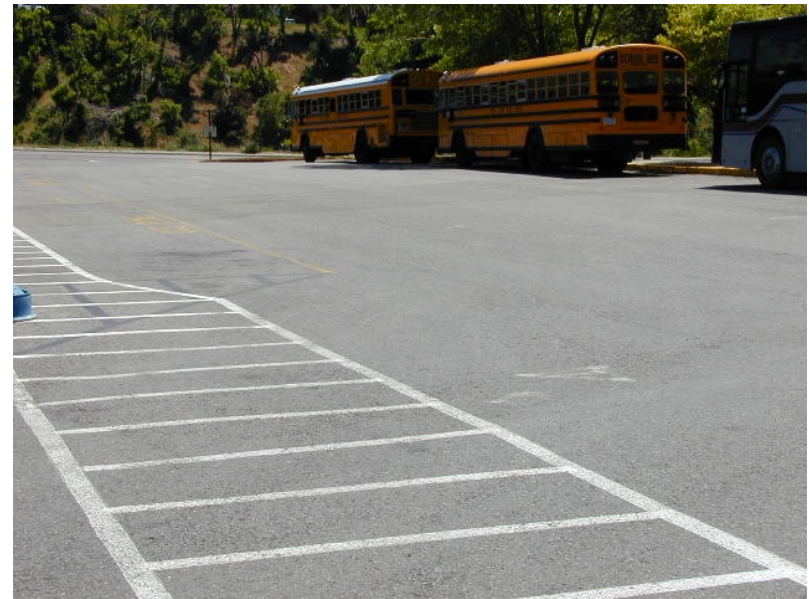
ID 87

Close to access to East Capitol Blvd. and to the Capitol building.

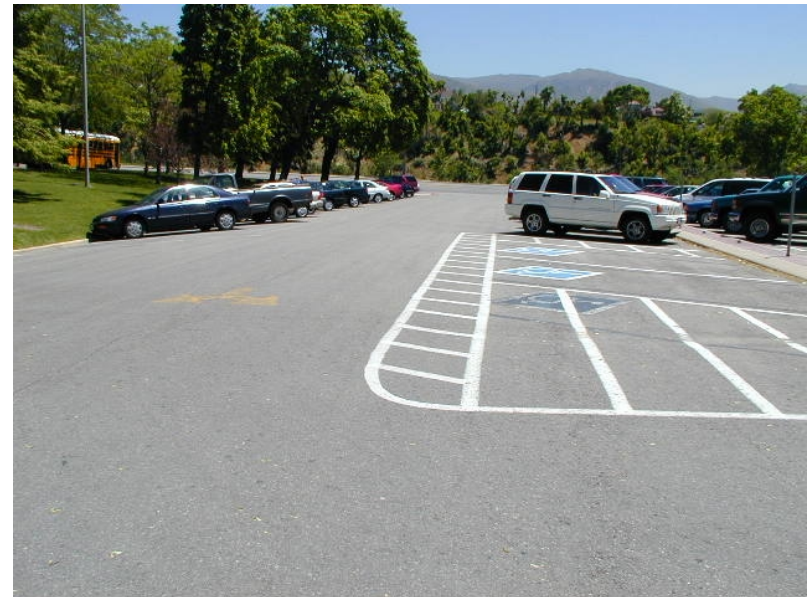
**ID**    **88**

*Comments:*                      Asphalt, good condition, with handicap stalls.

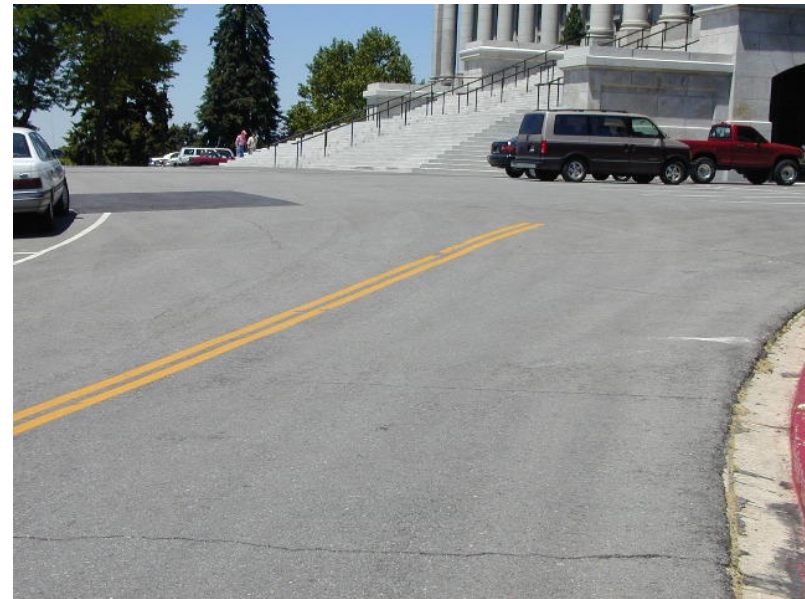
ID 90

Asphalt, good condition. Note limited and unaesthetic parking location.

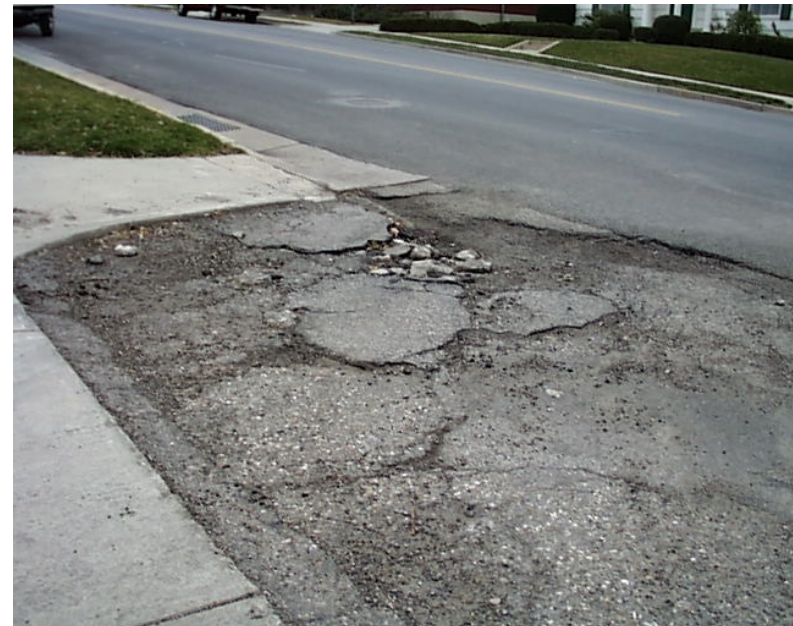
ID 91

Exfoliated or spalled surface; needs repair and correction of water

Asphalt deterioration due to poor drainage, loose gravel.

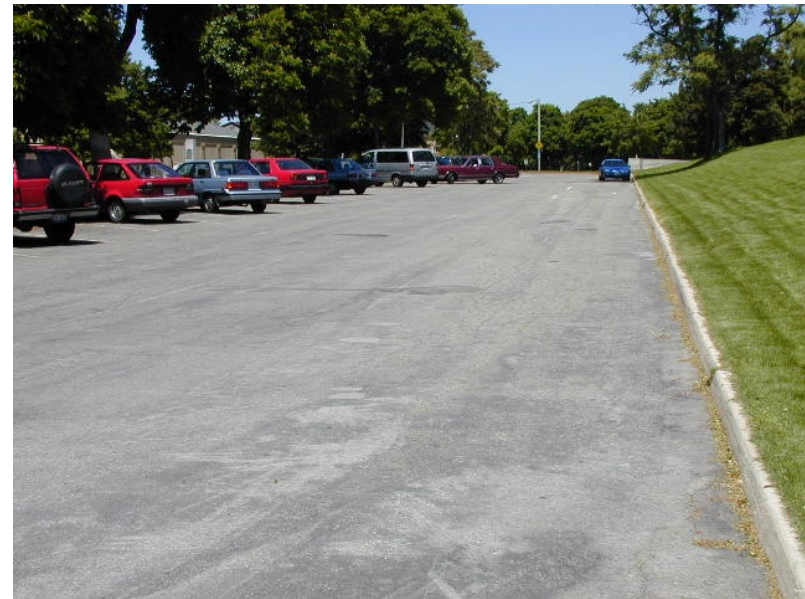
ID 92

Good condition. Large asphalt parking area for monument or D.U.P. Museum access.

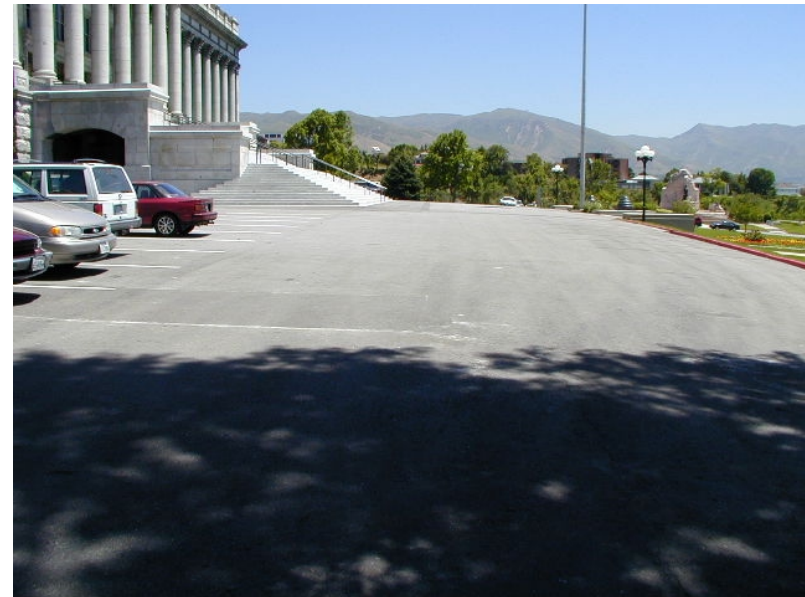
**ID**    **93**

Asphalt, good condition. Note limited parking and unaesthetic location.

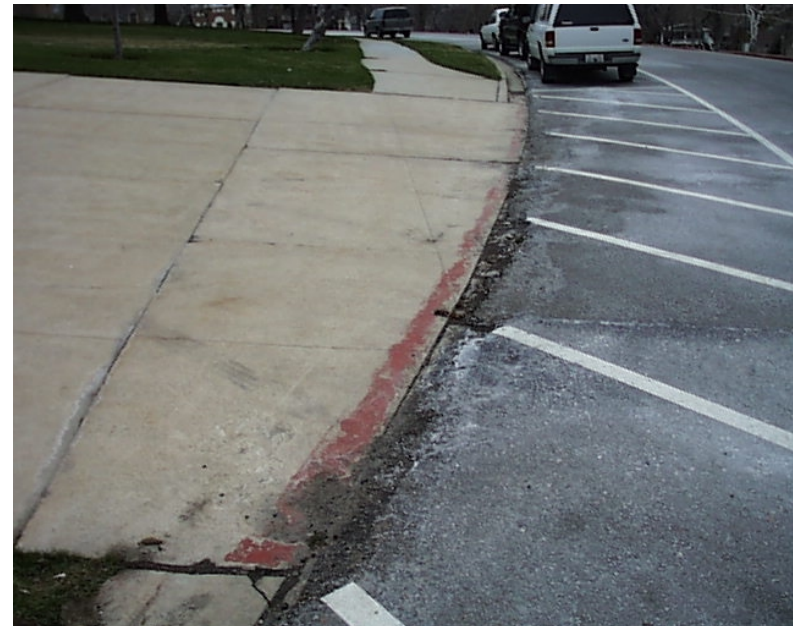
**ID**    **94**

Asphalt deterioration, loose gravel along parallel parking stalls.

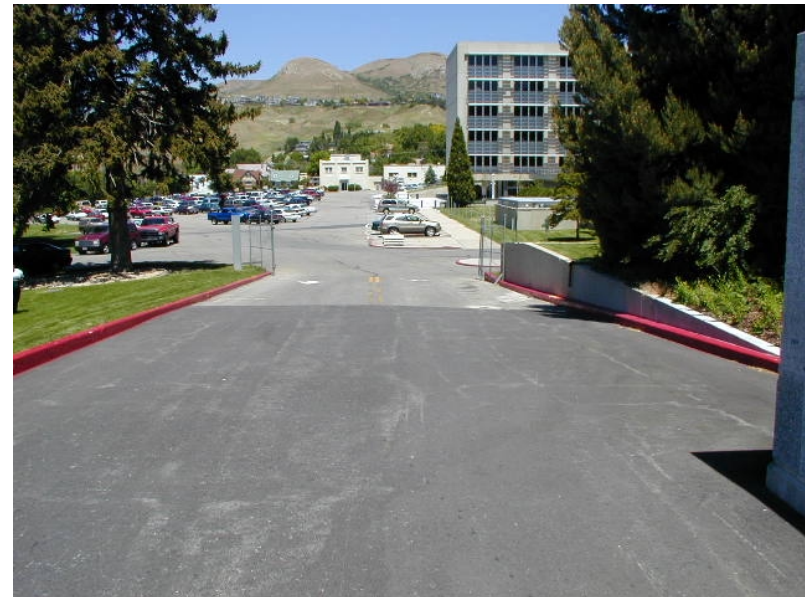
**ID**    **95**

Asphalt, good condition, no stripping. Note large asphalt area, adjacent to the Capitol building.

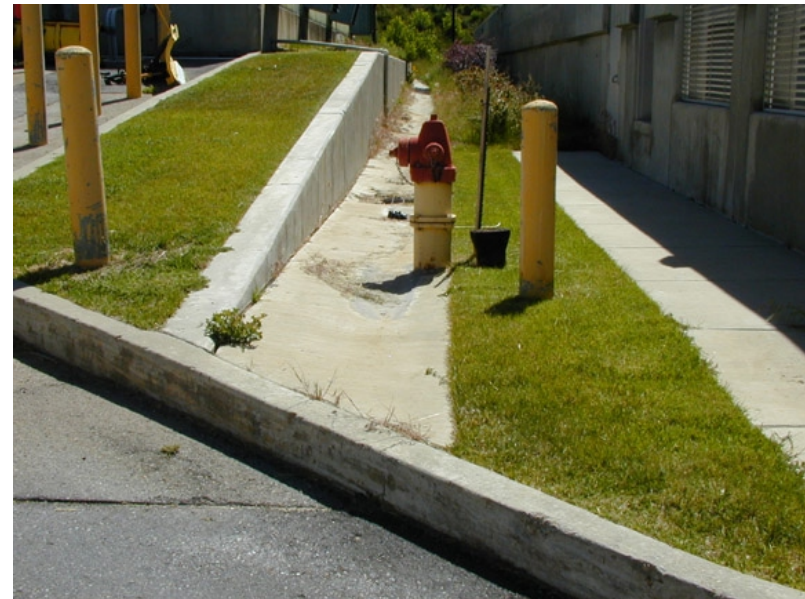
**ID**    **96**

Elevated wall to the right of hydrant limits  
access to hydrant for fire crews.

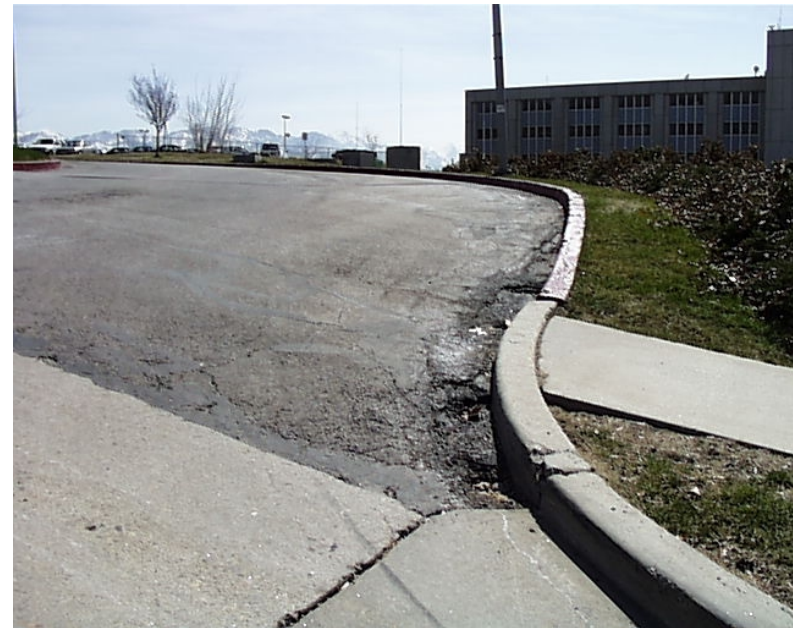
**ID** 97

*Condition Description:* Exfoliated or spalled surface; needs repair and correction of water

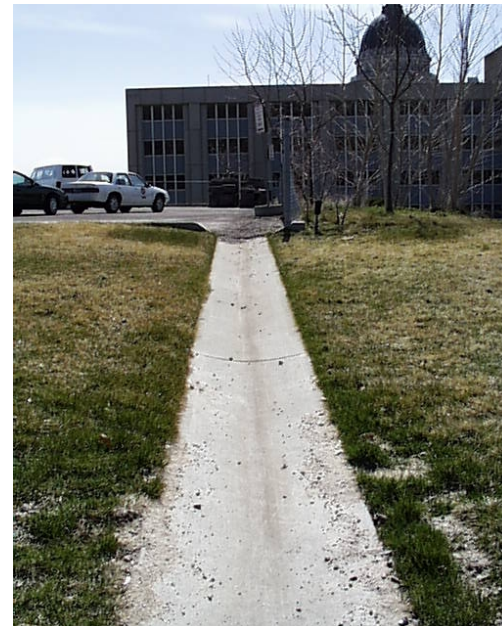
**ID**    **98**

Gravel from parking lot washes down waterway into gutter. Clean loose gravel from lot to keep gravel from entering storm drain system.

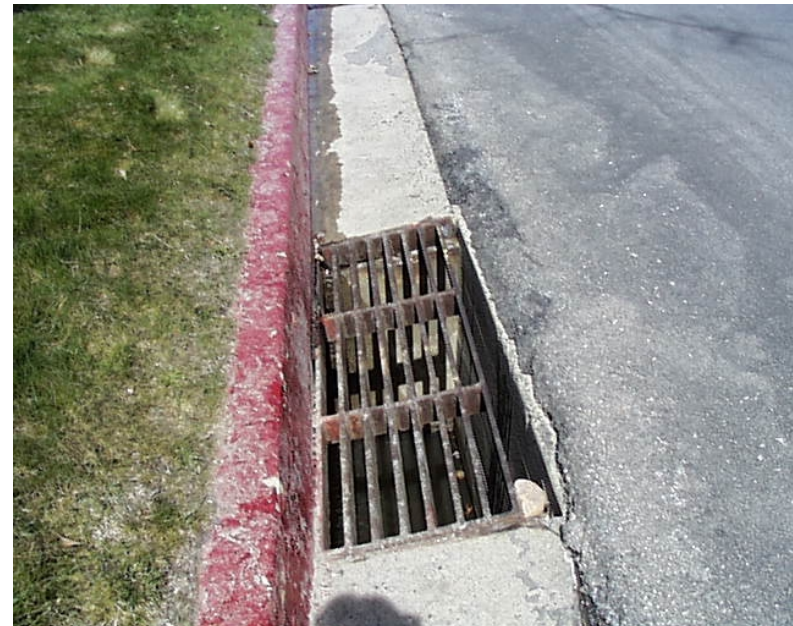
ID 99

Single functioning catch basin for all NE parking areas, not bicycle safe. Replace with bicycle safe grate.

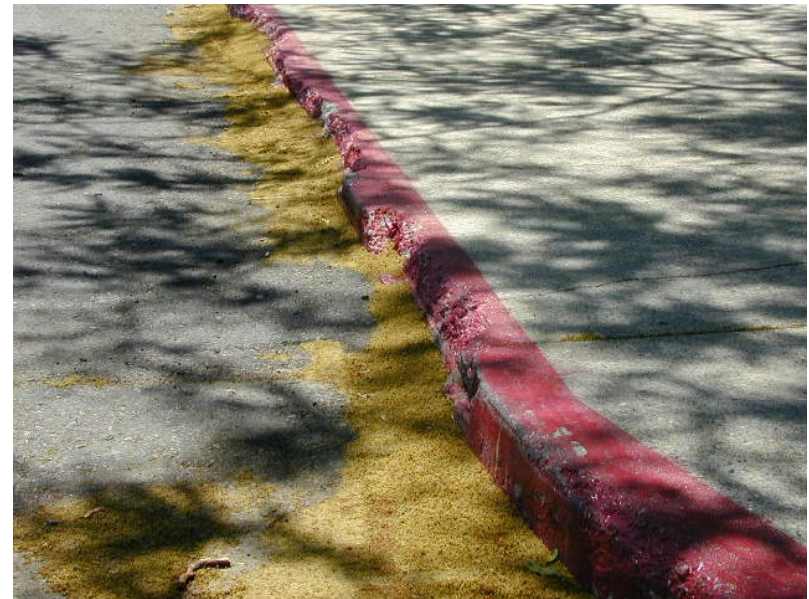
**ID**    **100**

*Condition Description:*   **Broken , severely cracked or  
chipped, needs repair or**

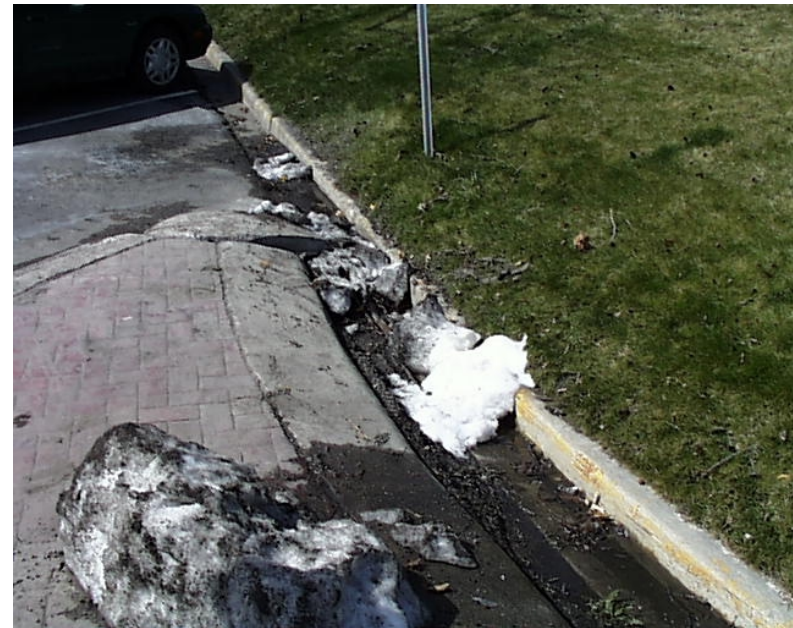
ID 101

*Condition Description:* General Cleaning Needed

Non-functioning catch basin around corner from non-bicycle safe catch basin mentioned previously.

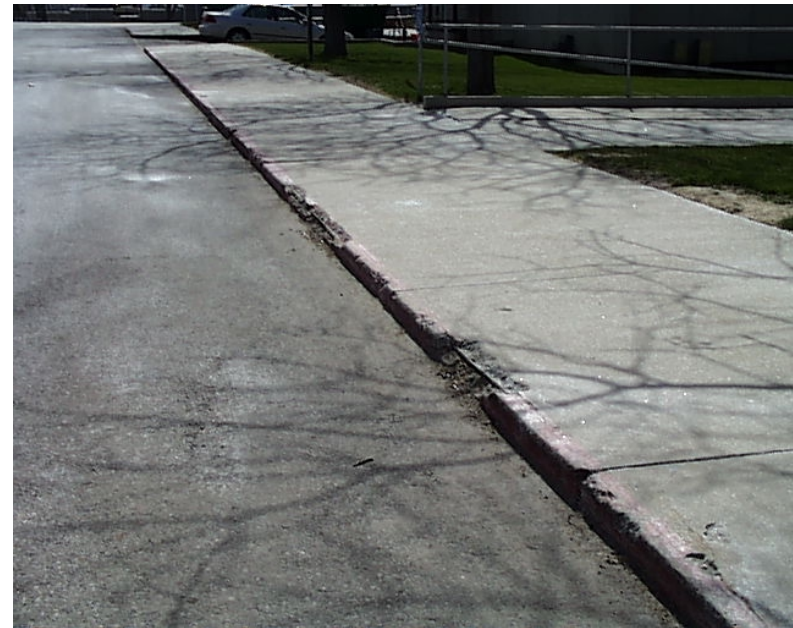
**ID**    **102**

*Condition Description:* Broken , severely cracked or  
chipped, needs repair or

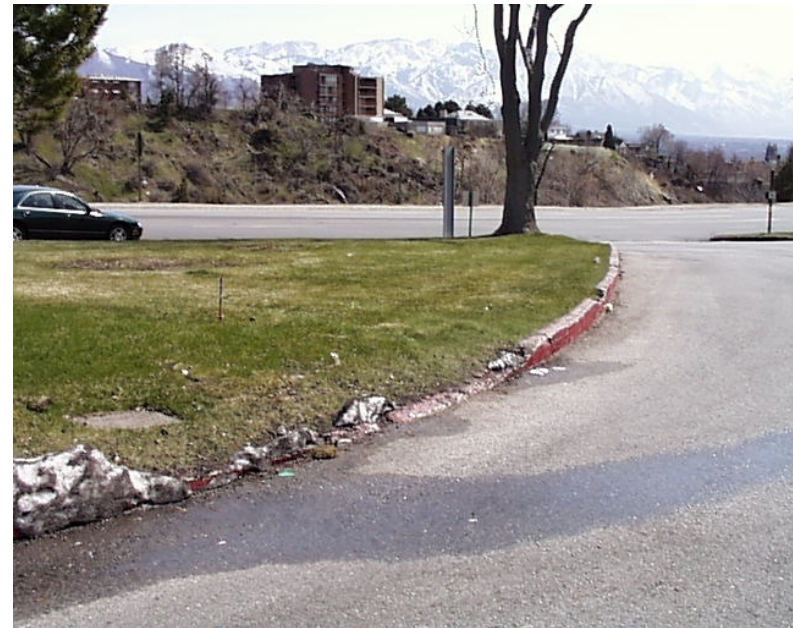
**ID**    **103**

*Condition Description:* Broken , severely cracked or  
chipped, needs repair or

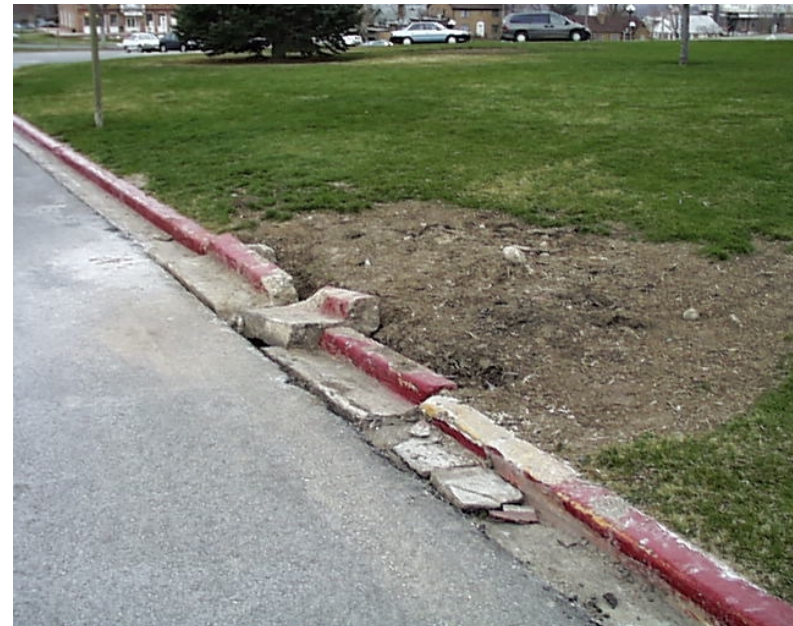
**ID**    **104**

Broken , severely cracked or  
chipped, needs repair or

Curb damage, asphalt deterioration at edge of  
gutter.

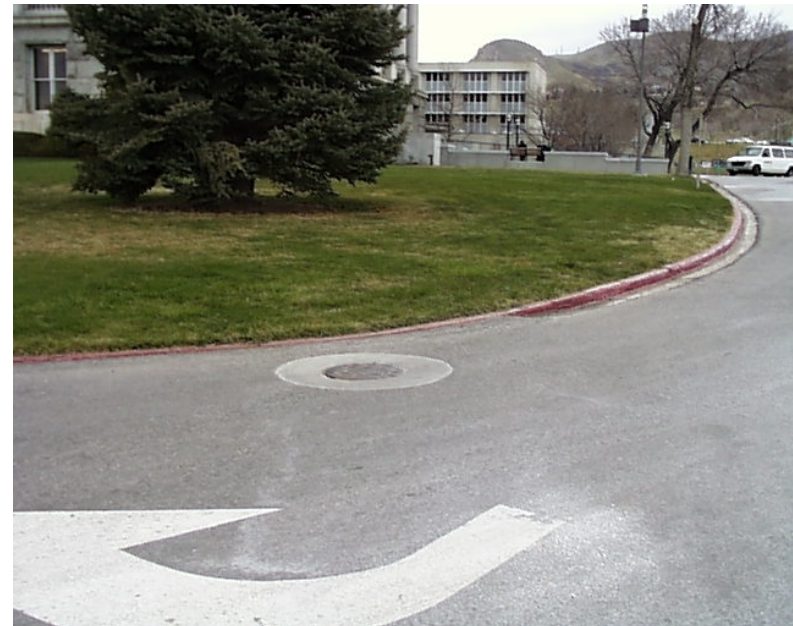
**ID** 105

Curb and gutter suddenly end forcing drainage onto access road. Reevaluate gutter flow.

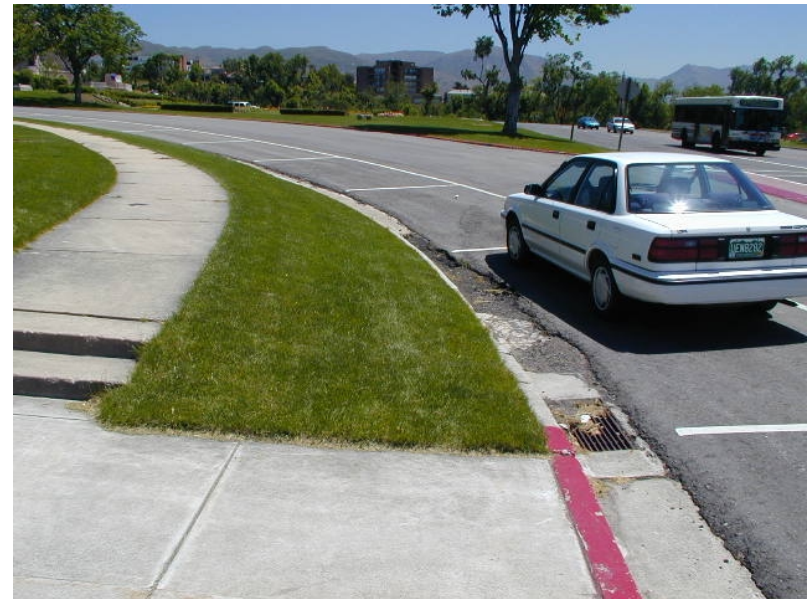
**ID** 107

Exfoliated or spalled surface; needs repair and correction of water

Gravel and debris plugging drain -- needs cleaning.

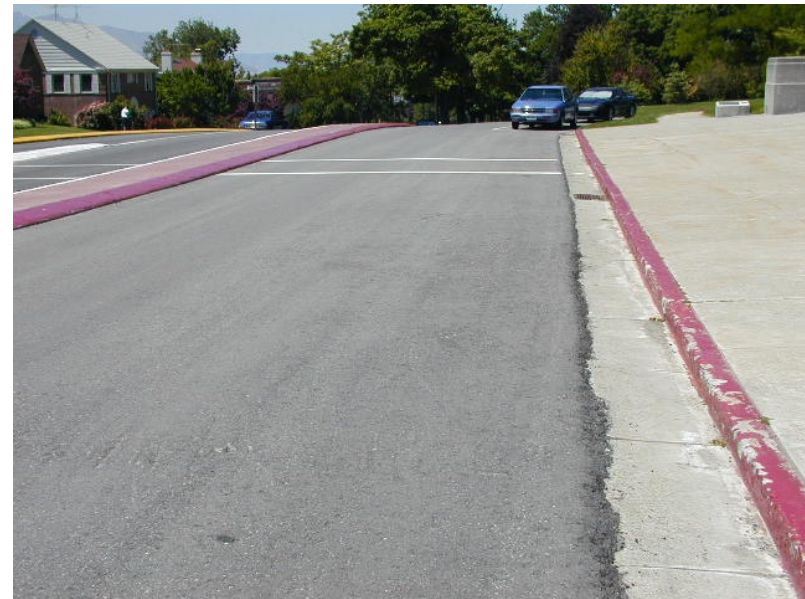
**ID**    **108**

Typical rough edge of pavement with gutter.  
Observe for large erosion areas that release gravel into storm drain system.

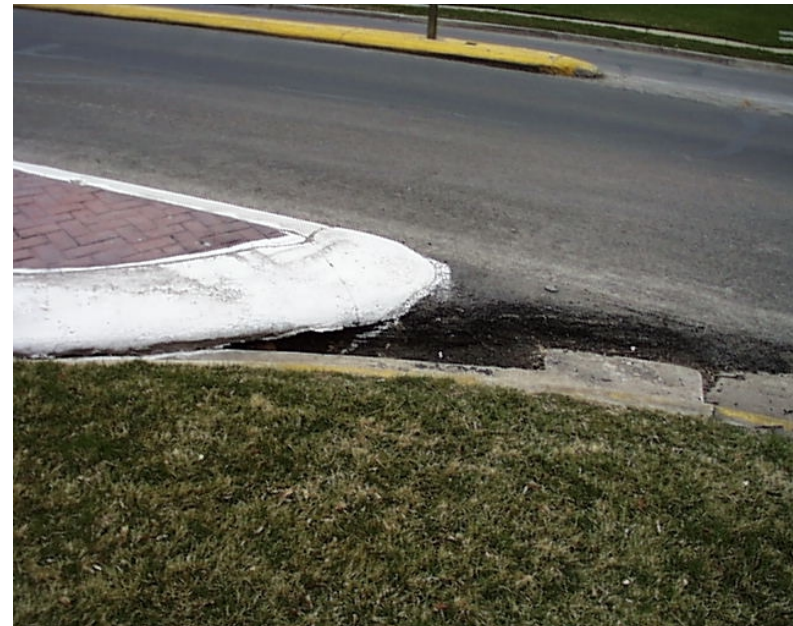
**ID** 109

**Condition Description:** Exfoliated or spalled surface; needs repair and correction of water

**Comments:** Erosion due to high velocity storm runoff. Repair asphalt.

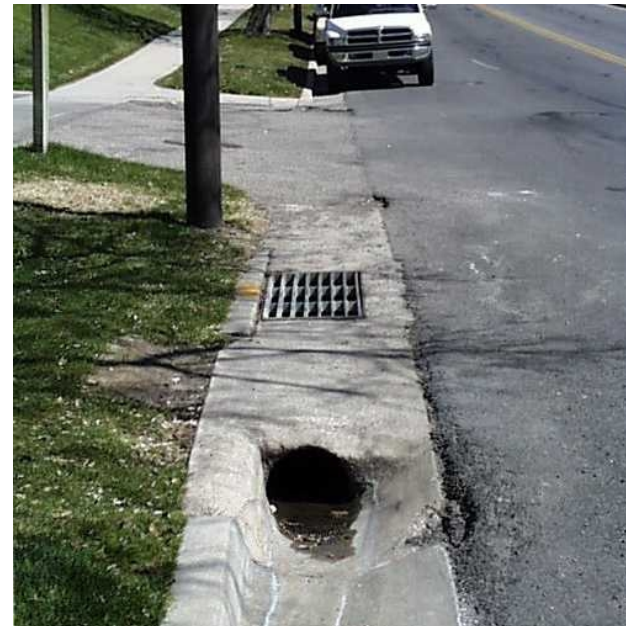
**ID** 110

*Comments:* Surface flow, to piped flow, then returned to gutter flow. Investigate reason for transition of flow.

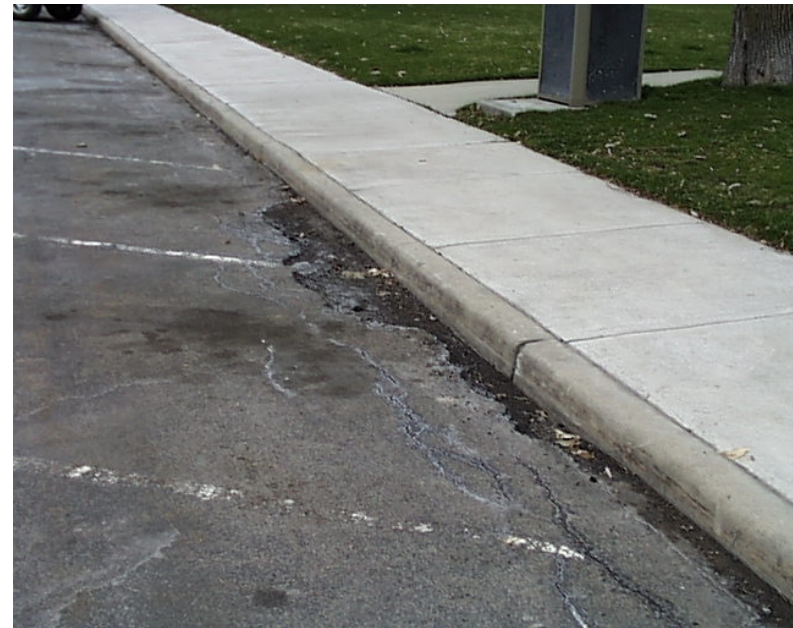
**ID**    **111**

*Condition Description:* Exfoliated or spalled surface; needs repair and correction of water

*Comments:* Repair asphalt.

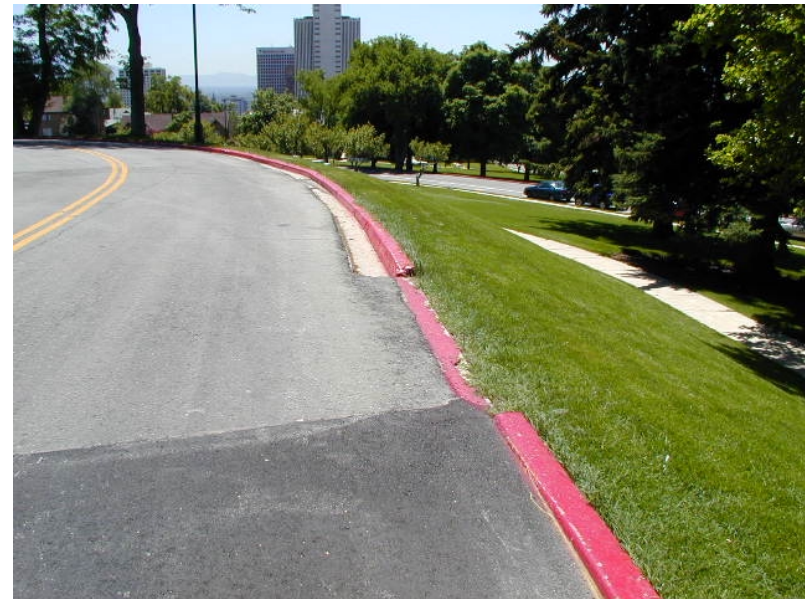
ID 112

Curb and gutter disconnect. Reevaluate runoff direction, redesign gutter where applicable.

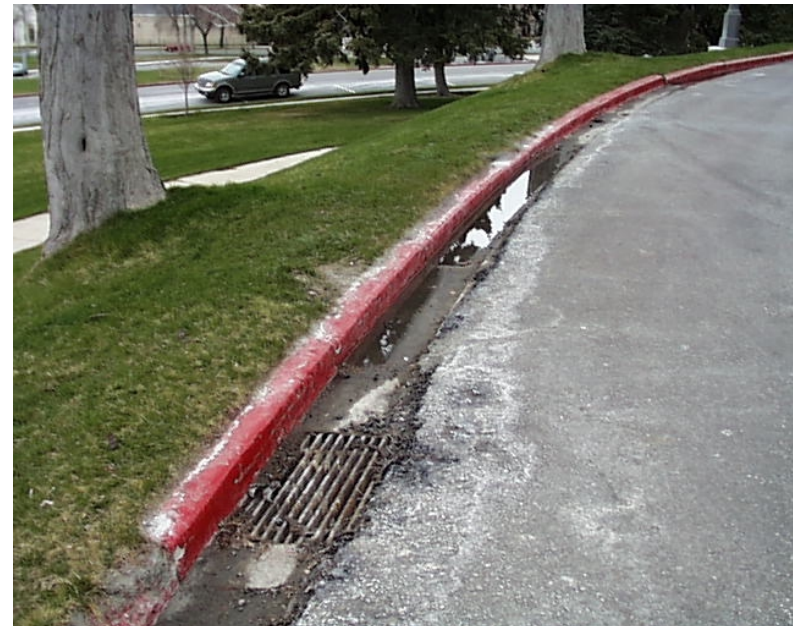
ID 113

Exfoliated or spalled surface; needs repair and correction of water

High point in gutter cuts off flow. Recommend replacement of approximately 150 feet of curb and gutter.

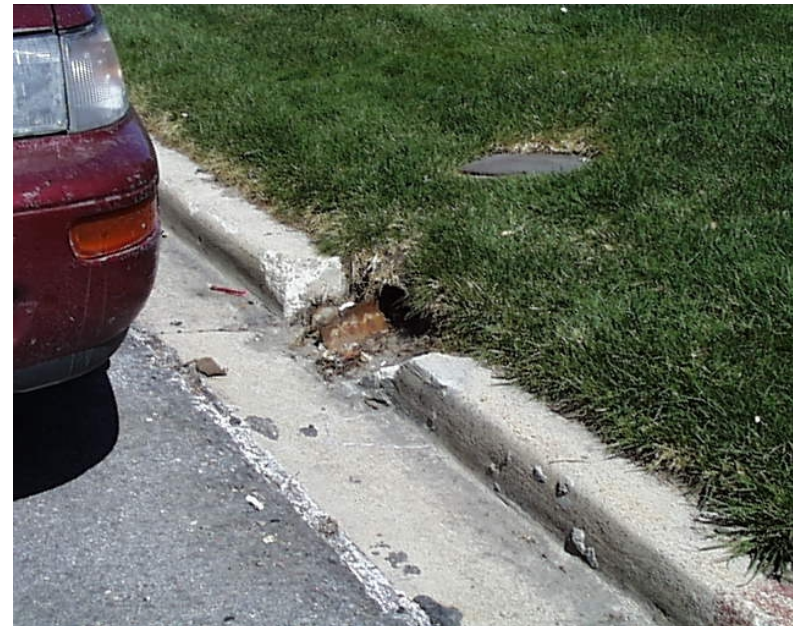
**ID**    **114**

Broken , severely cracked or  
chipped, needs repair or

Exit pipe appears broken, sharp edge exposed.

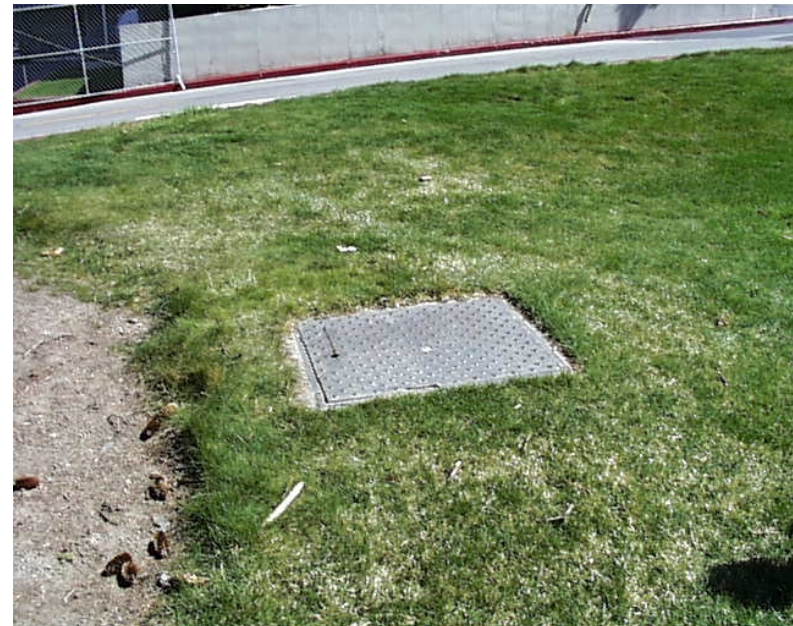
ID 115

Noted possible end to roof drain, could not open.

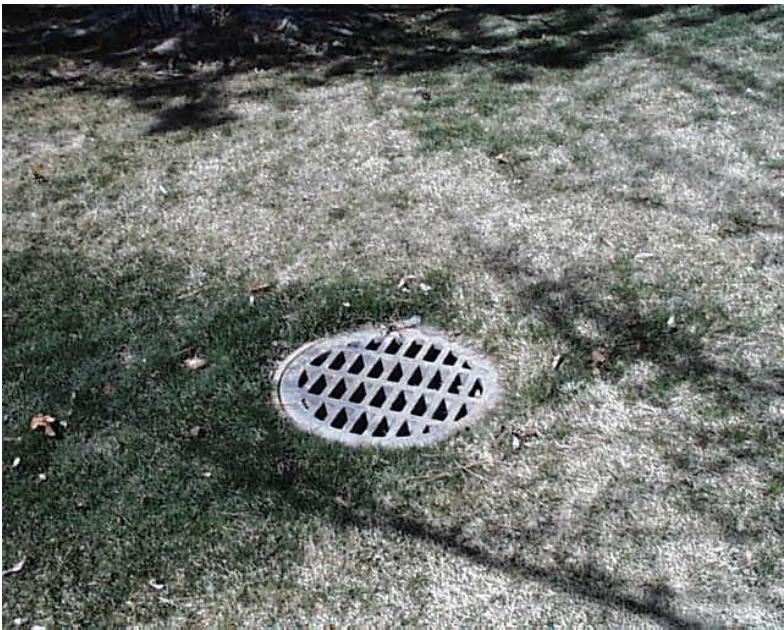
<b>ID</b>	<b>116</b>
-----------	------------

<i>Comments:</i>	Noted bubble up box on west lawn.
------------------	-----------------------------------

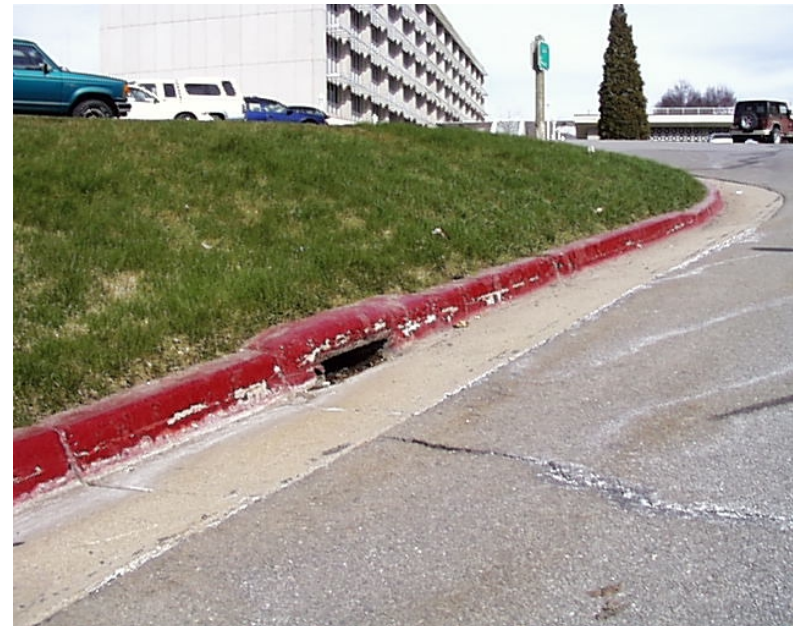
**ID** 117

Outlet from parking area, discharges to gutter flow. Curb and gutter in good condition.

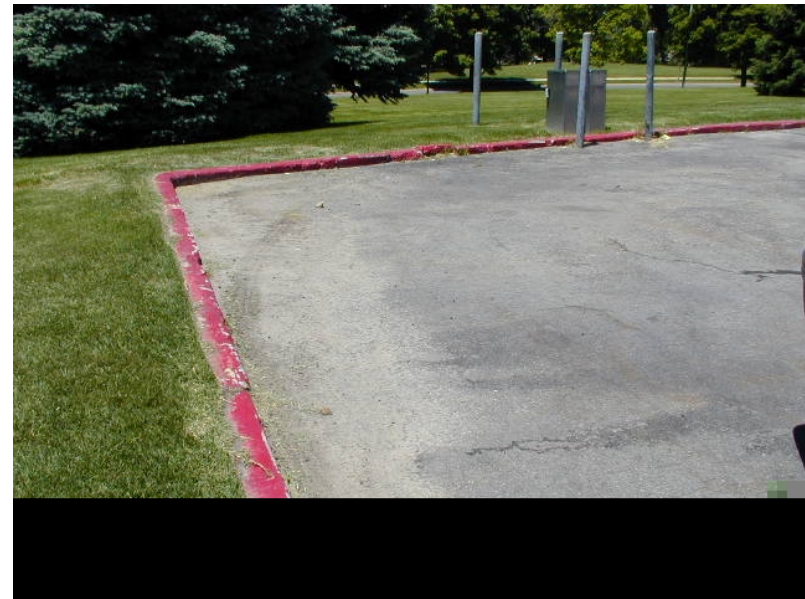
**ID** 119

**Category:** Curb/Gutter  
**Location:** NW parking area (south edge)  
**Satisfactory:** ☐  
**Damaged:** ☒  
**Condition Code:** BR  
**Condition Description:** Broken , severely cracked or chipped, needs repair or  
**Comments:** Replace approx. 30 feet of curb.
